Union Mine: Montgomery Shaft Site 5ST1141

Figure 2.9: Plan view of Union Mine: Montgomery Shaft site.

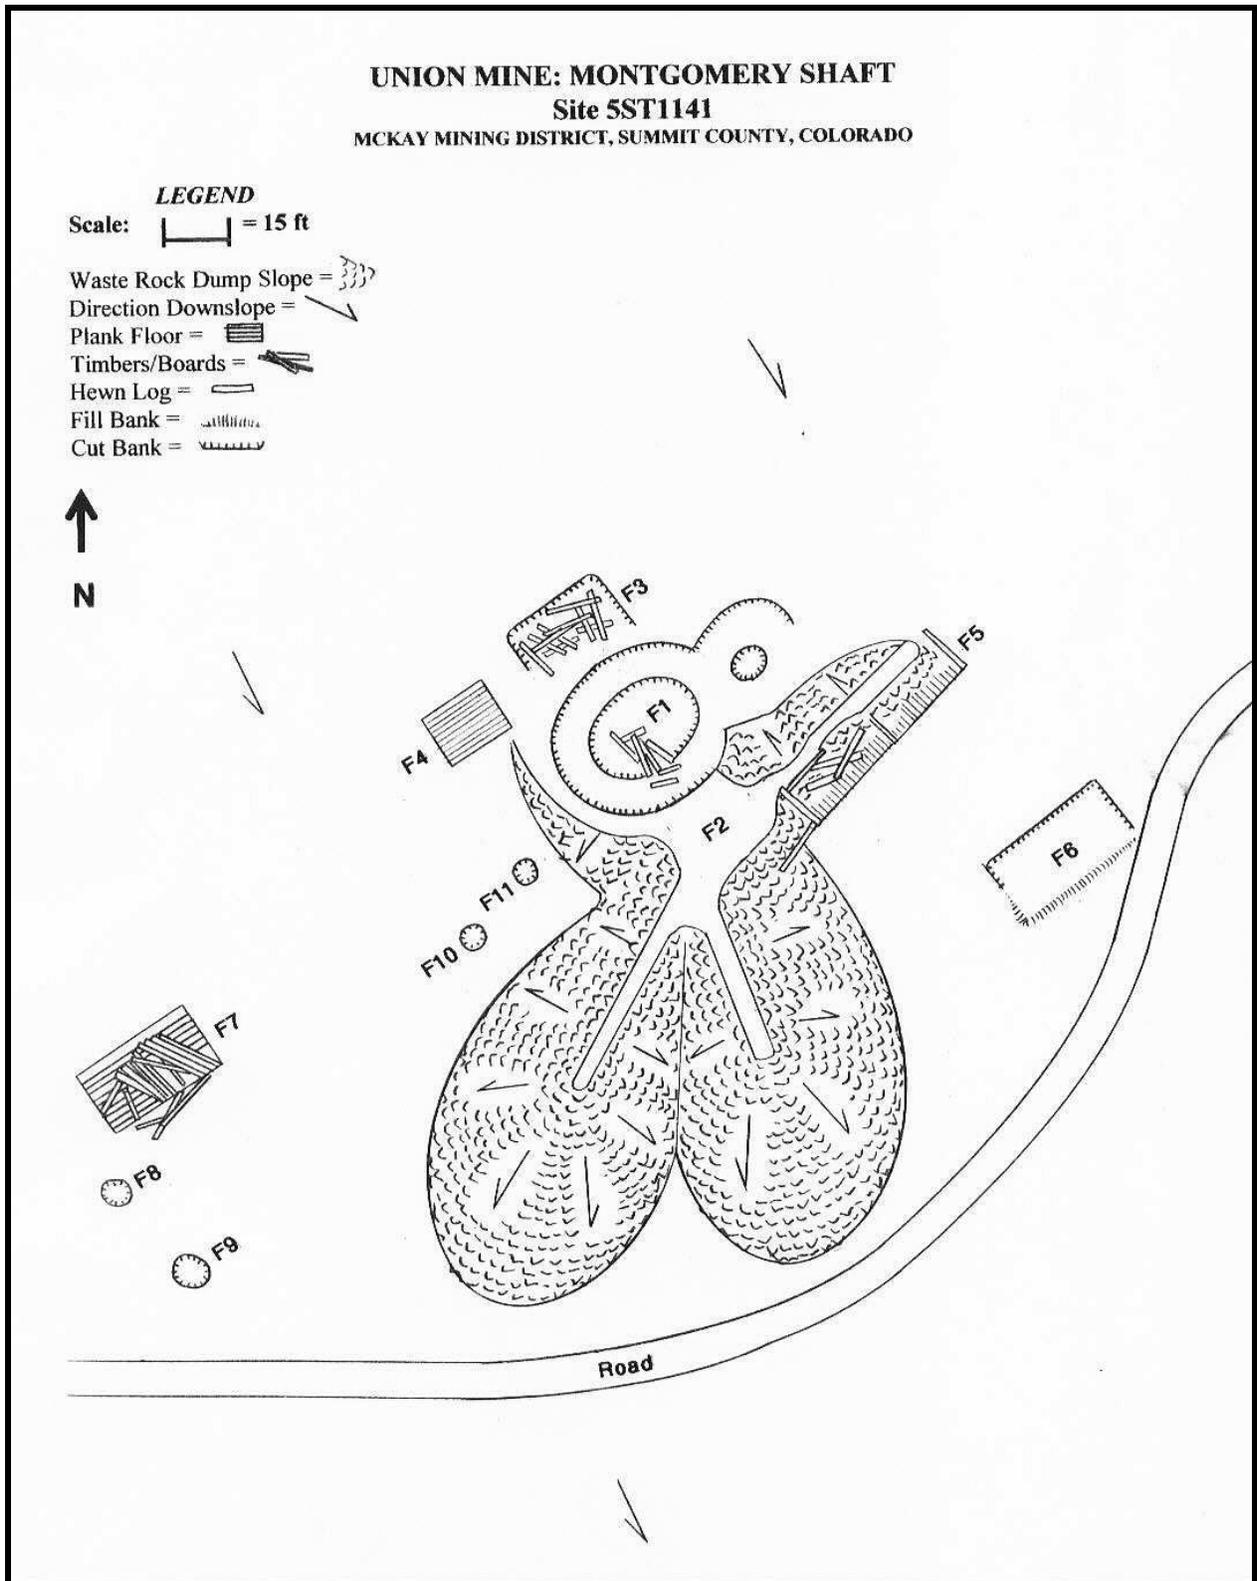
The site encompasses the archaeological remnants of the Montgomery Shaft, which was the Union Mine's first principal underground development. The mine's surface plant is clearly represented, although the shaft collar collapsed into a funnel that drew in portions of adjacent features.

As miners worked the shaft during the early 1880s, they dumped waste rock around the collar, creating a pad around 40 by 50 feet in area. When the Old Union company resumed work in 1904, miners extended the dump (F2) around 105 feet south in the form of two lobes. Over time, the waste rock dump attained the size of 108 by 125 feet in area and 18 feet thick.

When the Old Union company constructed a new surface plant in 1904, workers cut a platform (F3) at least 18 by 25 feet in area out of the mountainside for a frame hoist house, which is gone. The platform may have been larger, but the south portion was drawn into the shaft when it collapsed. The remnants of a plank wall and a water pipe for the mine's boiler extend out of the platform's cut-bank.

A frame blacksmith shop, now collapsed, stood adjacent to and west of the hoist house. Cut nails indicate that the shop was one of the original buildings erected at the mine. The building (F4) was front-gabled, 10 by 16 feet in area, and featured a 2x4 post-and-girt frame sided with planks. The shop stood on a foundation of log joists laid on a cut-and-fill platform large enough for the building. A light scatter of shop refuse extends downslope.

An ore bin stood at the southeast base of the waste rock dump, and it, too, was one of the mine's original structures. The bin (F5), partially collapsed, was an open flat-bottom type divided into two cells, each being 8 by 20 feet in area. The bin consisted of a log cribbing foundation, a 2x8 plank floor, and plank walls supported by log cribbing. A trestle crossed over the bin to allow miners to input pay rock from ore cars. Currently, the bin walls collapsed, allowing waste rock to erode over the floor.

A frame boardinghouse, now collapsed, stood west of the mine. The building (F7) was 14 by 25 feet in area and stood on 2x8 floor joists laid on a cut-and-fill platform slightly larger than the structure. The walls consisted of a 2x4 post-and-girt frame sided with planks, and the floor consisted of more planks. Few artifacts are present, duff probably conceals additional items, and meaningful buried deposits are unlikely. A combination of wire nails, hand-finished bottle fragments, and a hole-in-cap can assembled with an inner-rolled and soldered side seam indicate that Old Union company erected the building around 1904.

Because the site is relatively stable and faces no direct threats, management recommendations are few. The site lies on a historic road currently used for non-motorized recreation. In such a location, the site provides an excellent opportunity to educate the public regarding the history of the Union Mine. Management recommendations suggest installing interpretive signs.
