Lucky Mine and Mill
Site 5ST1149

Lucky Mine and Mill Site Description

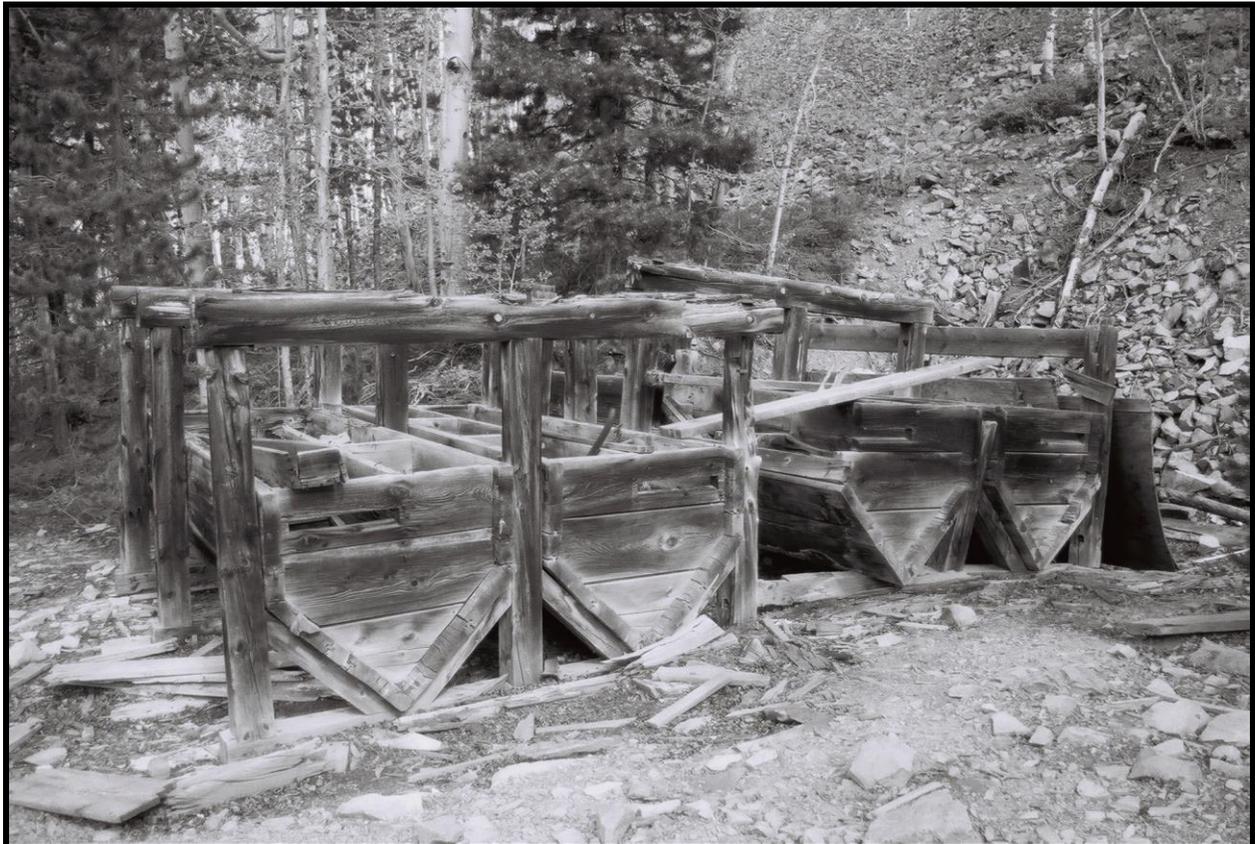
Fine material that passed through the screens proceeded to the concentration platform (F10), where two jigs separated out the waste. The platform is 18 by 34 feet in area and around 1 foot lower than the rest of the mill platforms so gravity could deliver ore to the jigs. Both jigs (F8, F9) currently remain intact on the concentration platform. The jigs are factory-made units 8 feet wide, 9½ feet long, and 6 feet high. They stand on timber bolsters and feature two symmetrically opposed V troughs. The interior of each trough is divided into compartments that were filled with water. In the compartments, agitation plungers and screens classified crushed ore by specific gravity.

Figure 2.20: A pair of jigs stands in place on the Lucky Mill's concentration platform. Water currents agitated by plungers separated crushed ore particles by specific gravity. Jigs were common at one time, but few examples currently survive. For this reason, the units on-site are rare and important examples. Source: Author.

Of great importance, the mill complex offers five relatively intact pieces of equipment, which lend some engineering integrity to the site. The equipment includes two jigs used to concentrate ore and three trommel screens that classified crushed ore by particle size. At one time, these pieces of machinery were universal throughout Colorado, and few examples currently survive.

Second, the two jigs are vulnerable, perishable wooden appliances that are currently exposed to the elements. Management recommendations suggest constructing a shelter over the machines to keep them dry.
