Union Mine: Shaft No.1
Site 5ST1155

Union Mine: Shaft No.1 Site Description

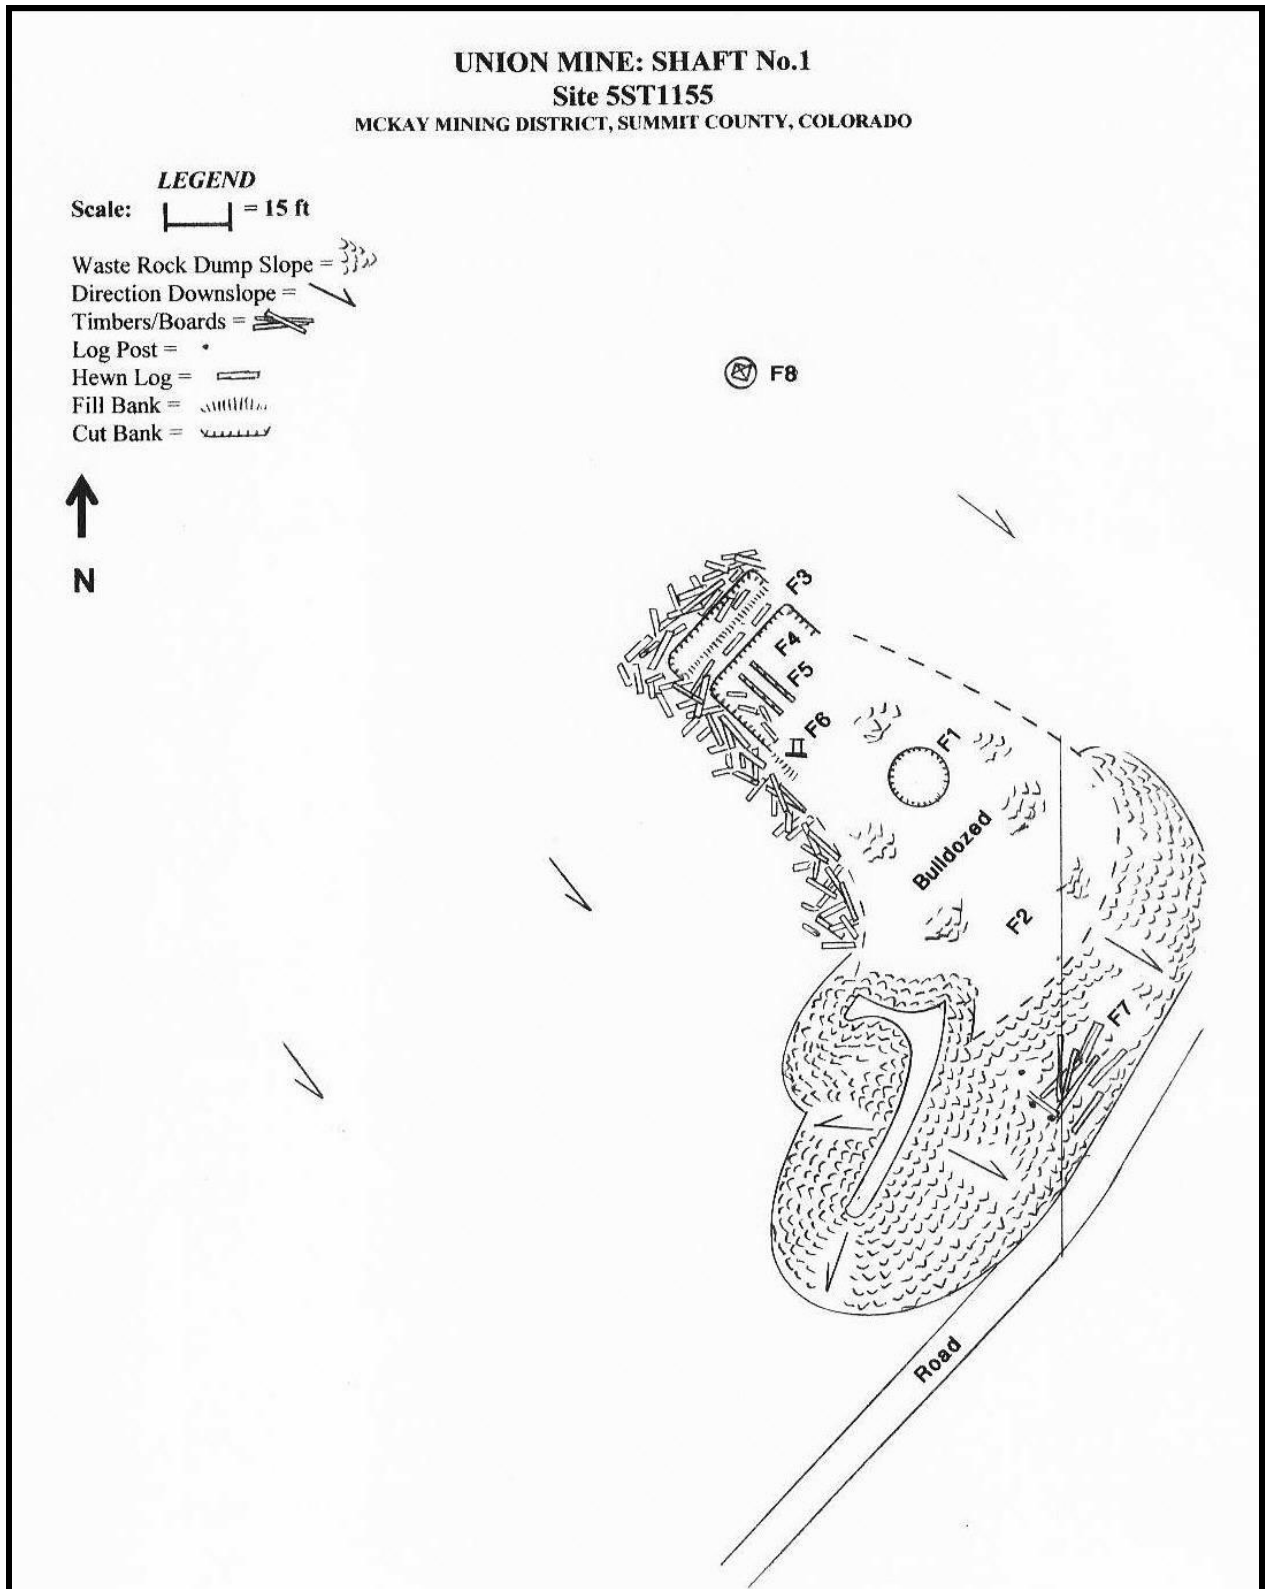
Figure 2.10: Plan view of the Union Mine: Shaft No.1 site.

The site encompasses the archaeological remnants of the Shaft No.1 complex, which suffered extensive disturbance when the shaft was capped. Specifically, the property owner bulldozed most of the waste rock dump and surrounding ground into the shaft, damaging nearly all the site's features. When intact, the dump (F2) was 98 by 140 feet in area, 12 feet thick, and featured a lobe extending southwest from a main pad.

A frame shaft house extended northwest from the shaft and enclosed the mine's hoisting, compressed air, and steam systems. The building (F3) stood on a platform graded with a combination of cut-and-fill methods and waste rock. When the shaft was bulldozed closed, the platform's southeast portion was destroyed and remnants of the shaft house pushed to the west. The platform was 25 feet wide and has been reduced to a length of 36 feet. The mine's hoist was located on a pad of earth (F4) 5 by 12 feet in area. Broken pieces of a rock masonry foundation and several pipes currently represent the machine, which has been bulldozed to the south. An air compressor, now gone, was anchored to a timber foundation (F5) near the center of the shaft house. The foundation consists of parallel 10x10 timbers, and its footprint indicates that the compressor was a 4½-by-11 foot, straight-line steam unit.

Workers erected an ore bin at the southeast base of the waste rock dump to store pay rock between shipments. The structure (F7) was an open, flat-bottom bin 12 by 34 feet in area with a plank floor. Log posts, several of which currently stand, supported the walls, which are gone. Most of the bin was damaged when waste rock was bulldozed into the shaft.

Between 1904 and 1909, the Old Union Mining & Milling Company ranked among the Breckenridge area's important operations. Today, the Shaft No.1 site retains little historical integrity due to extensive bulldozing. For this reason, the site is no longer a viable entity and contributes little to French Gulch's historic landscape. Management recommendations suggest no further consideration as a cultural resource.
