COLORADO CULTURAL RESOURCE SURVEY

Architectural Inventory Form

- 1. Resource number: **5ST130.101**
- 2. Temporary number: **N/A**
- 3. County: **Summit**
- 4. City: **Breckenridge**
- 5. Historic building name: **Willoughby House**
- 6. Current building name: **Miller House / The North Face**
- 7. Building address: **322 S. Main Street**
- 8. Owner name: **Dogfaces LLC**
 Owner address: **P.O. Box 5590**
Breckenridge, CO 80424

48. Report title: **Breckenridge Historic District Historical Building Survey**

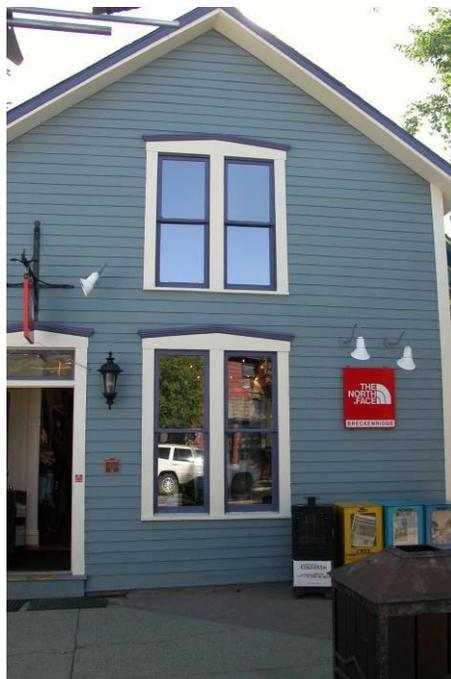
Built in 1880, the building at 322 S. Main Street in Breckenridge is a two-story wood frame building which originally measured 182 feet N-S (across) by 30 feet E-W (deep). To this original building, a 142' by 182' shed-roofed extension was added in the years prior to 1902, and a much more recent (circa 1980) 10' by 10' gabled addition was built onto the north (side) elevation. The building is of wood frame construction, and is supported by a stone or concrete foundation. The exterior walls are clad with painted blue horizontal wood siding, with painted white 1" by 4" corner boards. The roof is a moderately-pitched front gable, with brown asphalt shingles, and with boxed eaves with painted cream white and purple trim. There are no chimneys. Two sets of paired 1/1 double-hung sash windows (one set in the first story, and the second set directly above in the second story), penetrate the facade wall. These windows feature painted purple wood frames, painted cream white wood surrounds, and pediments. Windows elsewhere are primarily 1/1, 2/2, and 4/4 double-hung sash, with painted purple wood frames and painted cream white wood surrounds.

The main entry into the building is located at the north end of the facade where there is a painted blue with purple trim wood-paneled door, with one upper sash light, a transom light, and a pediment. Another wood-paneled door (similar to the door on the facade except that it is lacking a transom light and it is not pedimented), enter the building on the south elevation. This doorway is covered by a flat roof which also serves as a second story balcony. The porch roof / balcony is supported by four tall chamfered wood posts (painted cream white with purple trim), which continue to rise to support a gabled roof over the balcony. The balcony also features an open wood railing, while a solid wood door, with four upper sash lights and a wood screen door, enters from the balcony into the second story.

A 16' by 16' historic barn is located directly behind the building to the east, and is joined to the building by a small connector. (Sanborn insurance maps indicate that the building and barn have been connected in this manner since 1902.) The barn is supported by a wood timbers on grade foundation, and has vertical wood plank exterior walls. The barn roof is a moderately-pitched front gable, covered with badly deteriorated rolled asphalt roofing material over 1x wood decking and 2x wood rafters. A vertical wood plank door is located at the west end of the south elevation; a wood-paneled door is centered on the east elevation, below a fixed-pane 4-light window. Three windows on the north elevation have all been nailed over with horizontal wood planks; a vertical wood plank covered window opening is located at the east end of the south elevation.
