Architectural Inventory Form

| 5. Historic Building Name: | Mairs House | |
| 7. Building Address: | 108 N. French Street | |

48. Report title: **Town of Breckenridge Phase IV Cultural Resource Survey**

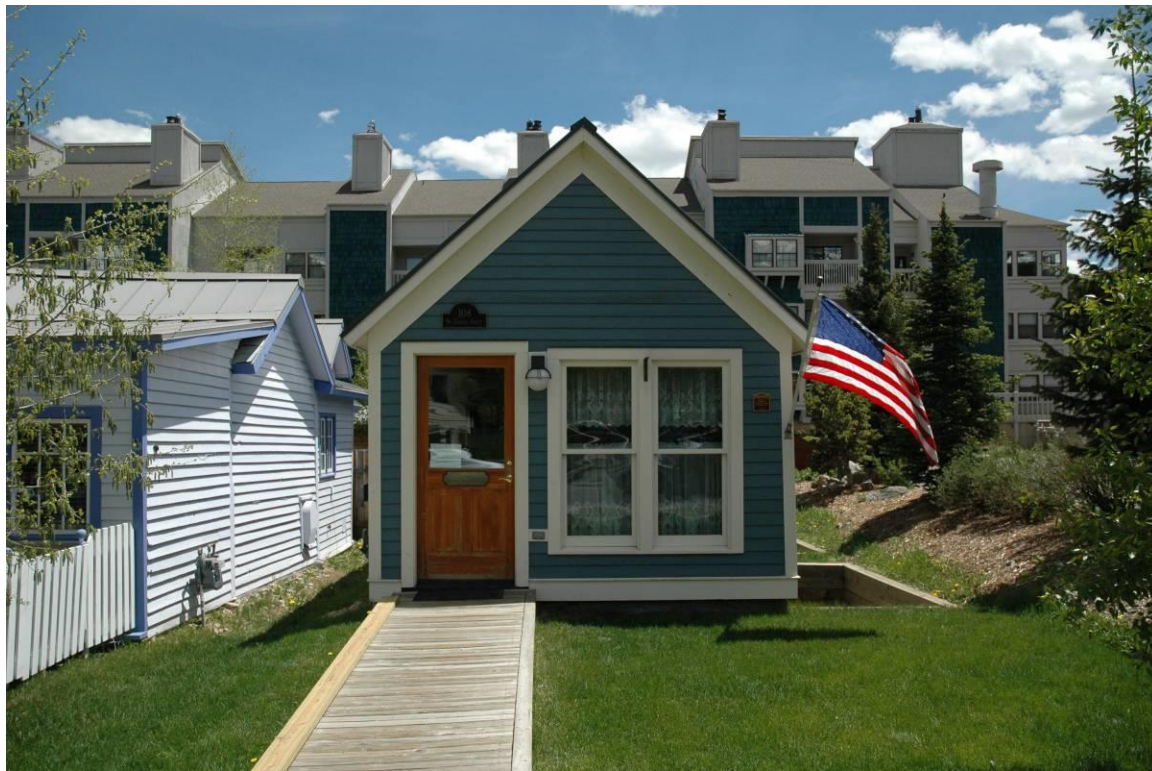
21. General architectural description:
The single-story wood frame building at 108 N. French Street is composed of an original (pre-1890), narrow, front gabled section, and a modest front gabled rear addition. The original building measures just 13' N-S (across) by 39' E-W (deep), while the rear addition measure 11' N-S by 22' E-W. The building is supported by a modern (1998) foundation with a full basement beneath the main level. The exterior walls are clad with painted blue horizontal wood siding, with painted cream white 1" by 4" corner boards. The front gabled roof is steeply-pitched, and is covered with metal roofing material. A set of paired 1/1 double-hung sash windows, with painted cream white wood frames and surrounds, penetrate the south half of the façade wall (west elevation). Three sets of paired 1/1 double-hung sash windows, and one single 1/1 double-hung sash window, also with painted cream white wood frames and surrounds, penetrate the south elevation. Sets of paired 1/1 double-hung sash basement-level windows are also located on the lower portion of the south elevation. No windows are located on the north elevation. A stained natural brown wood-paneled front door, with one upper sash light, enters the façade from a handicapped-accessible wooden sidewalk. A set of paired 10-light glass-in-wood-frame doors enter the basement level on the east (rear) elevation. A set of eight metal stairs descend to these doors.
