Architectural Inventory Form

| 5. Historic Building Name: | Norge Laundry | |
| 7. Building Address: | 105 S. French Street | |

47. Photograph number(s):	Breckenridge Phase IV Survey – CD-1; Images 91-96	Images filed at:	Town of Breckenridge 150 Ski Hill Road Breckenridge, CO 80424
48. Report title:	Town of Breckenridge Phase IV Cultural Resource Survey		
49. Date(s):	May 15, 2005		
50. Recorder(s):	Carl McWilliams	Rebecca Waugh	
51. Organizations:	Cultural Resource Historians	Town of Breckenridge	
52. Address:	1607 Dogwood Court Fort Collins, CO 80525	150 Ski Hill Road Breckenridge, CO 80424	
53. Phone number(s):	(970) 493-5270	(303) 629-6966 ext. 142

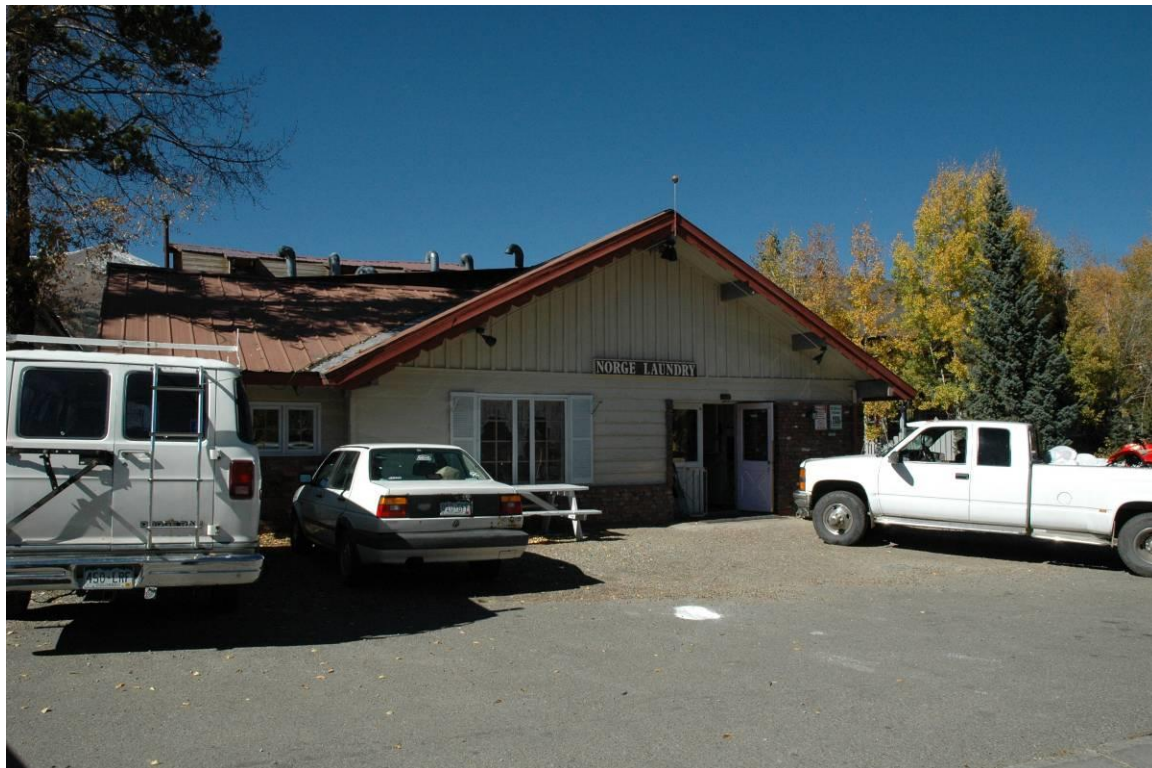
18. Roof configuration: **Gabled Roof/ Cross Gabled Roof**
19. Primary external roof material:
Other roof materials:
20. Special features: **N/A**
21. General architectural description:
The Norge Laundry is a single-story wood frame building which overall measures 44' N-S (across) by 34' E-W (deep). These dimensions include two off-set rectangular-shaped blocks, which respectively measure 24' N-S by 26' E-W, and 20' N-S by 32' E-W. The building's foundation is faced with brick, which also covers the lower portion of the façade wall on the east elevation. Elsewhere, the walls are clad with wide, painted beige, horizontal wood siding, with vertical wood siding in the upper gable ends on the east and west elevations. The cross-gabled roof is moderately-pitched, and is covered with red metal roofing material. The eaves are boxed with painted beige and buff red wood trim. A decoratively scalloped bargeboard appears along the eave on the façade (east) elevation. Two sets of paired, single-light windows penetrate the façade wall. Windows on the south elevation include an band of four 1/1 double-hung sash windows, and a set of paired single-light windows with triangular transom lights in the upper gable end. The north elevation is penetrated by a set of paired 1/1 double-hung sash windows, and two single 1/1 double-hung sash windows. A set of paired, painted purple, wood-paneled doors, each with one upper sash light, enter the building from within a recessed entryway near the north end of the facade. Meanwhile, a single, painted purple, wood-paneled door, with one upper sash light, enters the building at the south end of the façade. A set of paired, wooden. Service entry doors are located at the west end of the north elevation.
