COLORADO CULTURAL RESOURCE SURVEY

Architectural Inventory Form

- 1. Resource number: **5ST130.108**
- 2. Temporary number: **N/A**
- 3. County: **Summit**
- 4. City: **Breckenridge**
- 5. Historic building name: **House**
- 6. Current building name: **St. Mary's Catholic Church Rectory**
- 7. Building address: **115 S. French Street**
- 8. Owner name: **Catholic Archdiocese of Denver**
- Owner address: **unknown**
Denver, CO

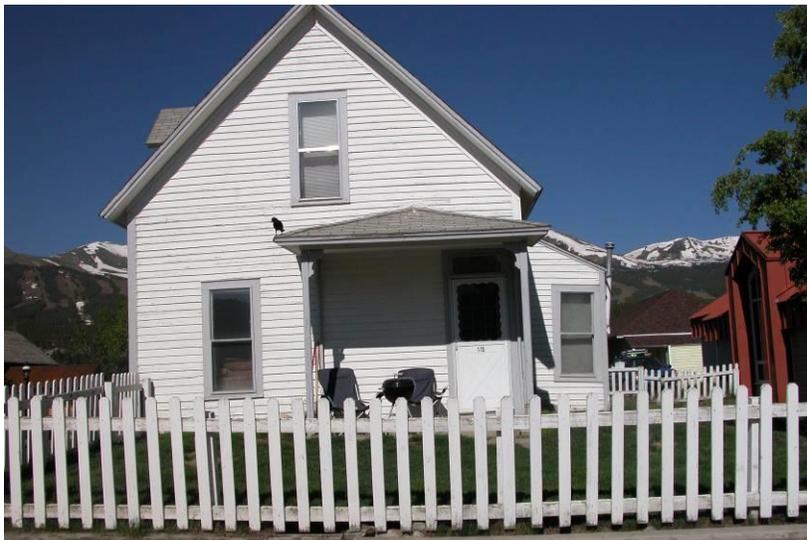
This building consists of an original 20' by 26' side gabled dwelling (built prior to 1890), along with what appears to be three historic additions, as well as an attached garage addition. A 6' by 16' shed-roofed addition has been built onto the original north (side) elevation; a 6' by 19' shed-roofed addition, and a 10' by 19' gabled addition, have been added to the original west (rear) elevation; and the 20' by 12' shed-roofed attached garage has been built onto the building's far west end. The entire building is of wood frame construction, and its exterior walls are clad with painted white horizontal wood siding, with painted blue-grey 1" by 4" corner boards. The roof is covered with grey asphalt shingles, and the eaves are boxed with painted blue-grey wood trim. Two gabled dormers, each with a 1/1 double-hung sash window, are located on the south elevation. A crumbling red brick chimney protrudes from the roof ridge.

The house's windows are primarily single and paired 1/1 double-hung sash, with painted blue-grey wood frames and surrounds; however, there is a 1x1 horizontal sliding window on the west elevation, a single-light fixed-pane window on the north elevation, two single-light fixed-pane windows on the south elevation, and a single-light fixed-pane window in the upper gable end of the original west elevation. A non-historic metal-paneled door, with nine upper sash lights, a transom light, and with a white metal storm door, leads into the house from a 10' by 6' concrete porch which is located near the north end of the facade. The porch is covered by a low-pitched hipped porch roof, supported by four painted blue 4" by 4" wood posts with decorative scrolled brackets. Another metal-paneled door leads into the building from a 4' by 19' concrete porch located on the south side elevation. A painted white wood-paneled roll-away garage door (no longer in use) is located at the west end of the south elevation.
