COLORADO CULTURAL RESOURCE SURVEY

Architectural Inventory Form

- 1. Resource number: **5ST130.95**
- 2. Temporary number: **N/A**
- 3. County: **Summit**
- 4. City: **Breckenridge**
- 5. Historic building name: **H.H. Vogan House**
- 6. Current building name: **The Bay Street Company**
- 7. Building address: **232 S. Main Street**
- 8. Owner name: **Two Thirty Two LLC**
 Owner address: **P.O. Box 2667**
Breckenridge, CO 80424

48. Report title: **Breckenridge Historic District Historical Building Survey**

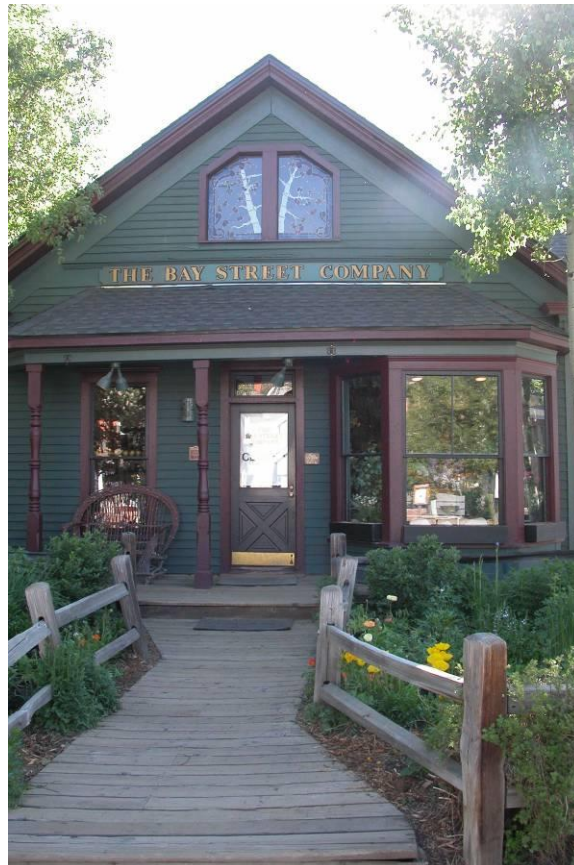
Originally a miner's family's cabin, the Bay Street Company building is located at the northeast corner of South Main Street and Adams Avenue in downtown Breckenridge. The building is 1 1/2-stories in height, and is of wood frame construction with painted green horizontal wood siding exterior walls and painted dark maroon 1" by 4" corner boards. The roof over the original cabin portion is front gabled; however, the entire building features intersecting hipped and gabled roof forms, with painted dark maroon boxed eaves and decorative scrolled brackets. A large, non-historic, red brick chimney is located near the east end of the south-facing roof slope. Historic windows include: a rectangular bay window, with four 1/1 double-hung sash windows, is set below an intersecting upper half story gabled addition, on the south elevation; a canted bay, with three 1/1 double-hung sash windows, which overlooks the south side of the front porch on the facade (west elevation); a 1/1 double-hung sash window which overlooks the north side of the front porch. Non-historic windows include: two fixed-pane stained glass windows in the upper gable end on the facade; four single and two sets of paired 1/1 double-hung sash windows on the north elevation; bands of three and five 1/1 double-hung sash windows on the south elevation; three sets of paired 1/1 double-hung sash windows in the upper half story on the south elevation; a band of five, and one set of paired 1/1 double-hung sash windows, located on the east elevation; one 1/1 single-hung sash window, located in the upper gable end on the east elevation. A non-historic wood plank porch extends across the full length of the facade, and wraps around to cover nearly all of the south elevation, paralleling Adams Avenue. A painted dark green wood-paneled door, with one upper sash light and with a transom light, leads into the building from the porch near the center of the facade. A set of paired painted green wood paneled doors, covered with wood screen doors, lead into the building from the porch on the south elevation. A painted dark green wood-paneled door, with one upper sash light, enters the building at the east end of the south elevation. A non-historic balcony on the south elevation is supported by five large, painted green, wood columns. Another, smaller, balcony is located at the east end of the south elevation. Two sets of paired 1x1 horizontal sliding glass bypass doors enter, from the balconies, into the building's upper half story.
