Wapiti Mining Company Office
Site 5ST372

Wapiti Mining Company Office Site Description

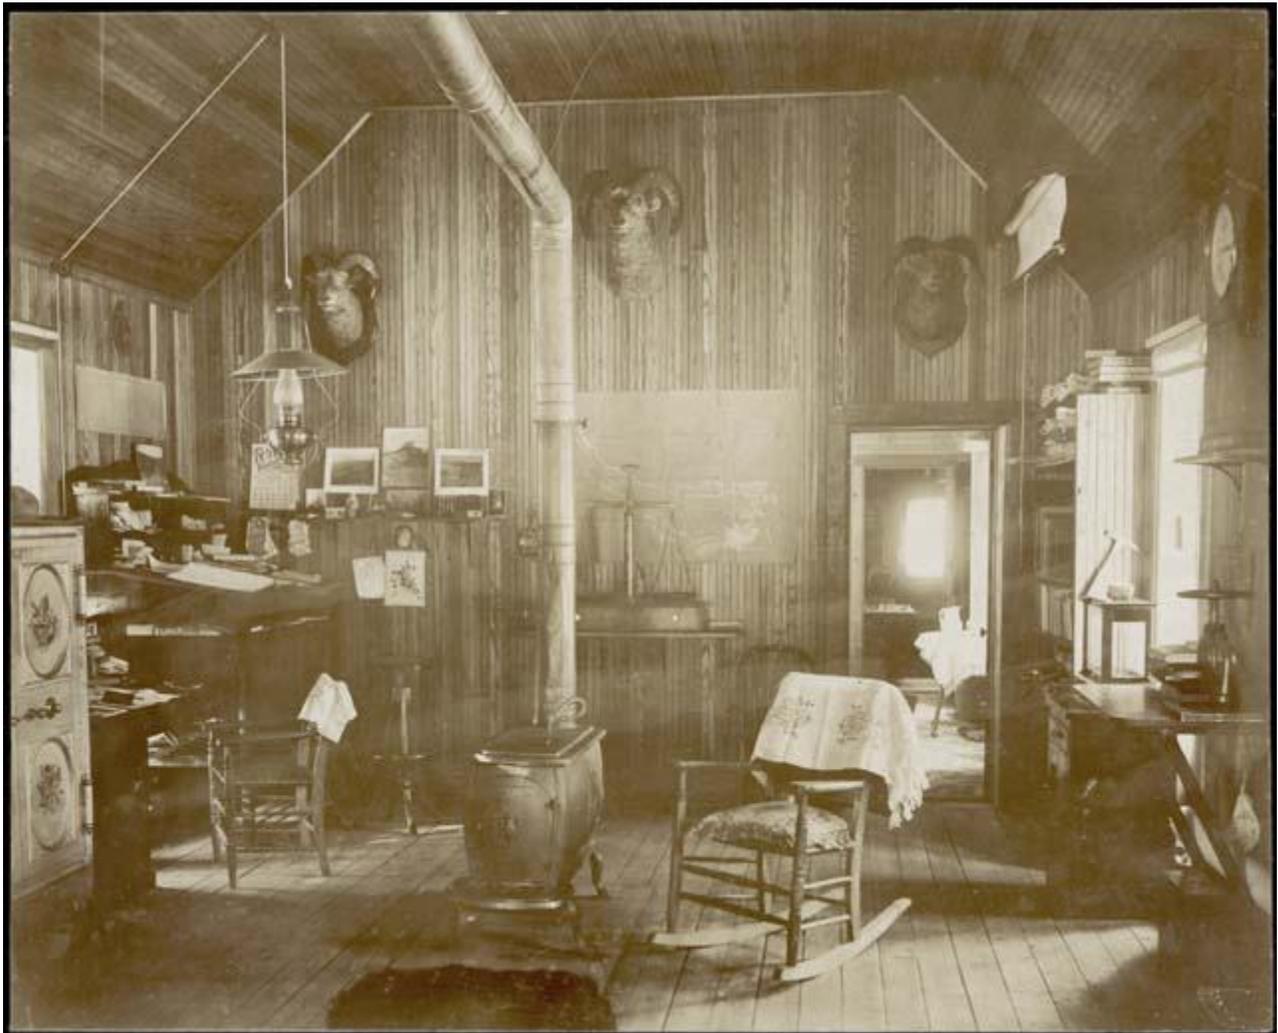
Figure 2.60: The 1890s view depicts the interior of the Wapiti Mining Company office. The interior is within an addition built against the main two-story office, visible through the doorway at right. Note the gold scale against the rear wall and the safe at left. Source: Denver Public Library, CHS-5441.

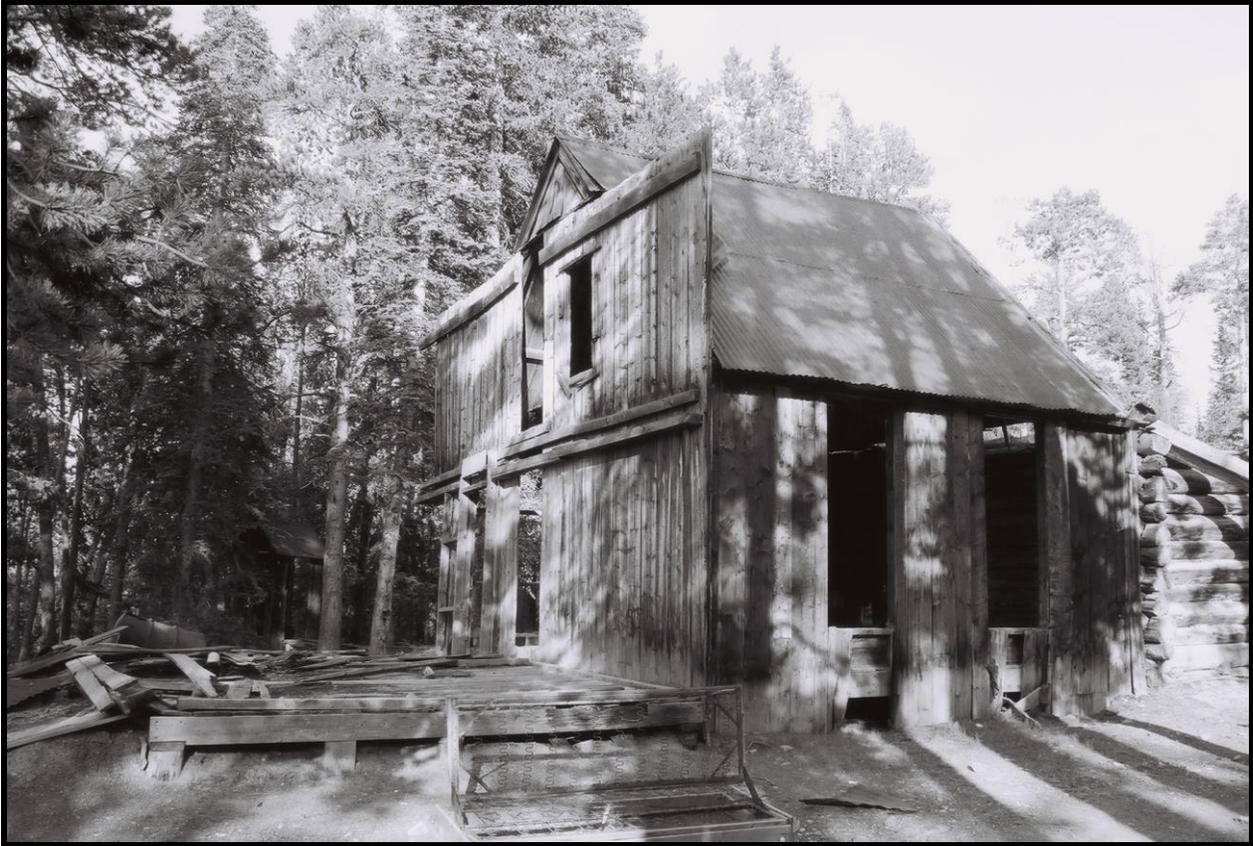
Figure 2.61: View east of the Wapiti Mining Company office today. A two-story building stood on the floor at left, a frame addition currently stands at right, and a log cabin is at far right. The interior photo above was taken within the addition, with a perspective from right to left into the two-story office. The log cabin at far right was probably built by the Fuller Placer Company during the 1870s. Source: Author.

Originally, the office (F1) was a side-gabled, two-story structure 13 by 22 feet in area and 17 feet high at the roof eaves. The top story was 7 feet high, the bottom story was 8 feet high, and a subframe elevated the building approximately 1½ feet above an underlying cut-and-fill platform. Workers excavated a root cellar 5 by 8 feet in area and 5 feet deep underneath the floor's east portion. The floor originally consisted of 1x7 planks nailed to 3x6 joists spaced 2 feet apart, and someone later nailed another layer of tongue-and-groove planks at a 90 degree angle. The walls consisted of two layers of planks nailed to a 2x4 balloon frame, and they stood on 2x4 footers nailed to 4x6 joists. Workers used cut nails for all primary woodwork and affected repairs afterward with wire nails. The ruin currently consists of a plank floor, subframe, and partial walls. The floor is intact, the north wall fell outward, and the roof and east and west walls are completely missing. A few historic artifacts lie scattered around, and shallow, buried deposits are possible on the north and east sides.

The office featured an addition, which currently stands on the south side. The addition (F2) is a story-and-one-half, front-gabled structure 17½ by 18 feet in area, 9 feet high at the roof eaves, and 19 feet high at the gable peak. The walls differ depending on the building side. The east and west walls consist of plank siding nailed to a 2x4 balloon frame on a foundation of 4x6s. The north wall has no frame and is shared by the adjacent office, and the south wall consisted of planks nailed to an adjoining log cabin (F3). The roof features 2x8 common rafters sided with planks clad by corrugated sheet iron. The second story is defined by plank flooring nailed to the roof's 2x9 tie beams. Workers used cut nails for the building's primary construction and affected repairs with wire nails.

A log cabin, one of the earliest buildings in the complex, abutted the addition's south side. The cabin (F3), partially collapsed, was a front-gabled log structure 17½ by 31 feet in area and 8½ feet high at the roof eaves. Workers assembled the walls with saddle-notch joints and chinked gaps with mud retained by lumber strips. The roof, now gone, was probably similar in pitch to the adjoining addition, and the floor consisted of planks nailed to log joists. The log foundation and the joists were laid on a gently graded platform augmented with fill removed from a shallow trench underneath that was used for storage. Workers used cut nails for all primary woodwork. While the surrounding ground is dense, shallow, buried deposits are possible along the south and west sides.

Third, the building ruins should be stabilized against further collapse. The site's standing building lacks siding and windows, which admits moisture. The missing siding and windows should be replaced. The adjoining log cabin ruin has already partially collapsed, and the remnants of the existing walls will topple in the near future. The walls should be supported with interior posts or buttresses.

Last, the office and the partially intact cabin can be rebuilt. One of the office's walls remains standing and the floor is intact, but the other walls and the roof are gone. New walls and a roof can be erected with little effort. To maintain the site's historical integrity, the new walls must match the original ones in terms of materials and workmanship. Fortunately, the office's north wall currently lies on the ground, and it can serve as a template for the new walls. The new roof can be modeled after the intact one that currently covers the adjacent frame addition.

The log cabin can be rebuilt with a combination of intact logs lying around the ruin and imported logs. The cabin's remaining walls are currently intact enough to allow for easy reconstruction. The new roof can be modeled after that covering the adjacent frame addition.

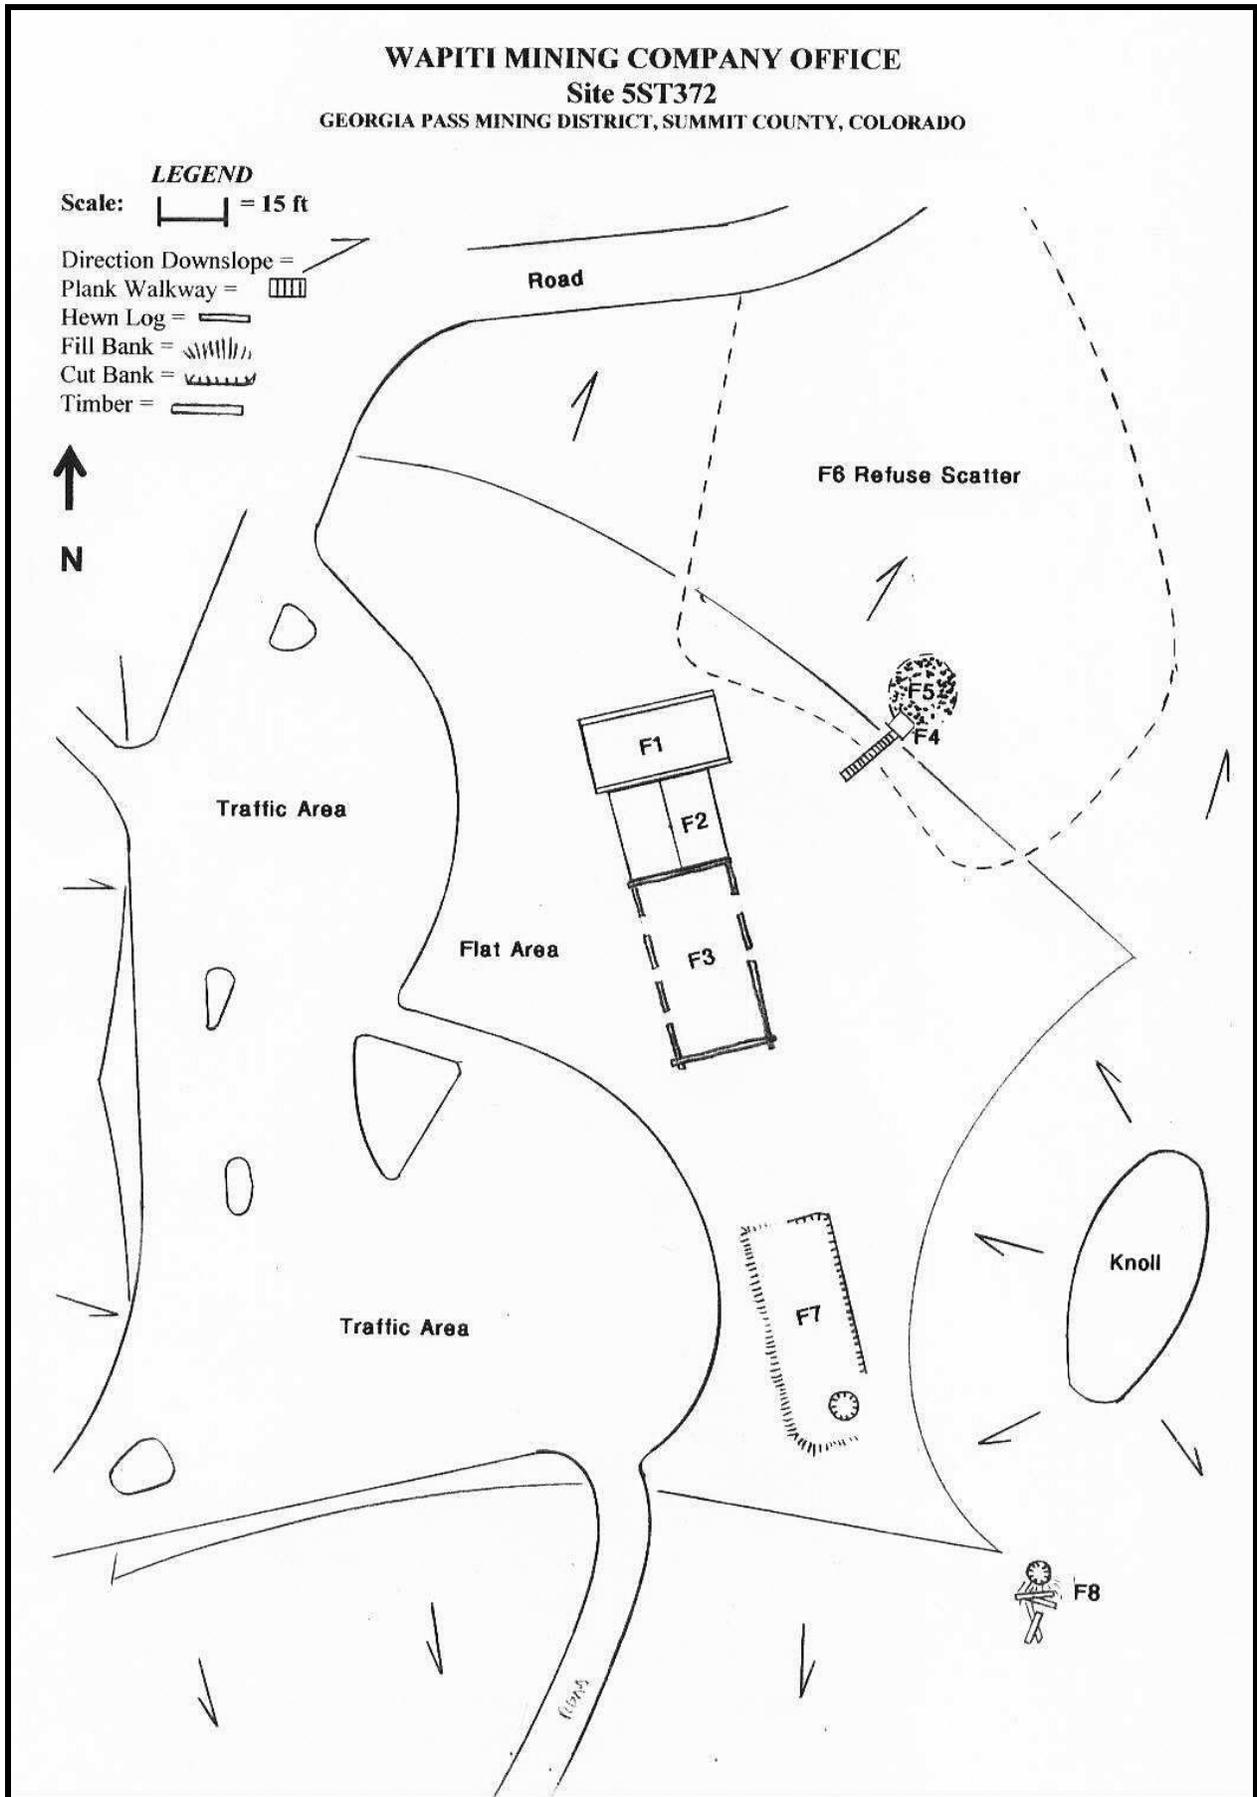
When intact, the complex featured four buildings including an office, quarters for management, and a residence for other staff. The office was the largest and most distinct building, and it has been reduced to a ruin.

The office residents disposed of their refuse in the manner common to western mining camps. Specifically, the residents relied on a privy for their personal use, dumped stove ash behind the privy, and threw solid waste downslope. The privy (F4) remains standing and is a side-gabled building 4 by 4½ feet in area, 6½ feet high at the roof eaves, and 9 feet high at the peak. The walls are little more than planks nailed to 2x4 cross-members, and the roof consists of planks and corrugated sheet iron cladding nailed to common 2x4 rafters. The building stands on a pedestal of 3x6 corner posts and plank siding that workers built into the underlying pit. A ventilation stack at the top of the roof evacuated foul odors. In recent years, someone built a plank walkway from the hillslope to the privy door. Workers used cut nails for all primary woodwork except in the walkway. The underlying pit, currently filled with modern garbage, was 2½ by 4½ feet in area and 5 feet deep. The pit was not much deeper, and hence, meaningful buried deposits are probably absent.

The dump (F5) behind the privy manifests as a mound of mostly stove ash and broken bottles approximately 20 feet in diameter. Buried deposits are present and shallow, and they probably mirror the surface artifact assemblage. When the residents threw their solid waste downslope, they formed a deposit (F6) of mostly food cans and broken bottles 105 by 126 feet in area. The scatter is largely surficial.

The complex featured a second log building, which stood independently south of the office. The building burned, leaving a cut-and-fill platform (F7) 18 by 48 feet in area. Workers excavated a cellar pit into the platform's south end and created a berm along the east edge to deflect snowmelt. The cellar collapsed and now manifests as a depression 10 feet in diameter and 4 feet deep. Sod along the south and west sides conceals small artifacts.

The log building possessed its own privy, which collapsed. The pit (F8) now manifests as a depression 3 feet in diameter and 2 feet deep excavated into slate bedrock. A small pile of backdirt indicates that the pit is shallow, in which case meaningful buried deposits are unlikely. Remnants of the privy building and some domestic refuse extend downslope.
