Minnie Mine: Main Workings
Site 5ST1145

MINNIE MINE: MAIN WORKINGS
Site 5ST1145
MCKAY MINING DISTRICT, SUMMIT COUNTY, COLORADO

Minnie Mine: Main Workings Site Description

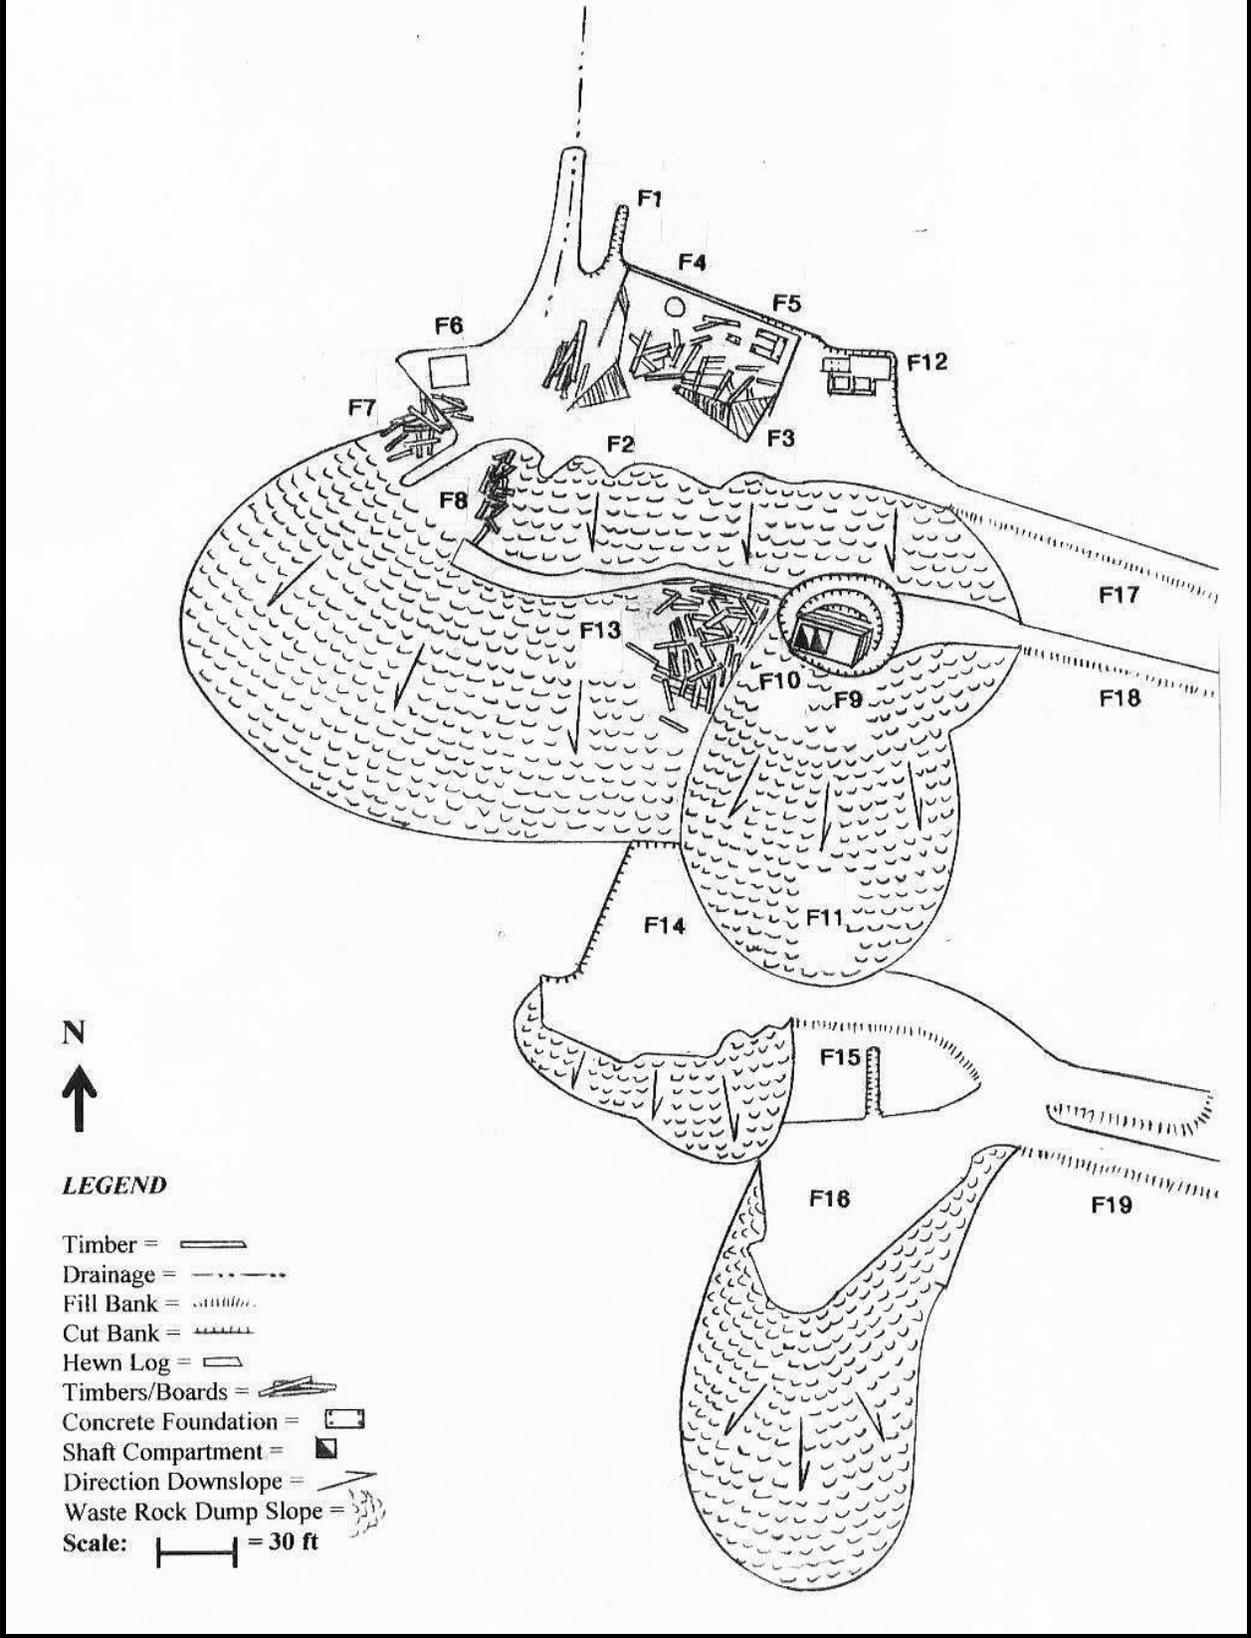
The Minnie Mine site currently features the remnants left from Davenport's 1950s operation. The tunnel (F1) is the only feature that clearly dates to the Minnie's early history. Like most tunnels in the region, the portal collapsed and is now a linear area of subsidence. The associated waste rock dump (F2) manifests as a broad terrace with scalloped edges that represent dead-end rail lines used to deposit the waste rock. Overall, the dump is 190 by 246 feet in area and 17 feet high.

Workers installed the compressor in the east corner of the compressor house, and the machine's Portland concrete foundation (F5) currently remains. The main foundation is U-shaped, 9½ by 12 feet in area, and 3 feet high. A pad for the drive engine extends northwest. The foundation's footprint confirms that the compressor was a belt-driven, multistage duplex unit.

The surface plant included a small, frame building used for storage on the west edge of the waste rock dump. The foundation (F6) currently remains, and it consists of a plank floor supported by cobbles.

The four-drum hoist that served the shaft stood on a cut-and-fill platform adjacent to and east of the compressor house. Currently, a concrete foundation (F12) remains. When Davenport reopened the shaft in 1955, his workers modified the foundation to accommodate a double-drum electric hoist. The front, south portion of the foundation features anchor bolts for the hoist and two wells for its cable drums. Behind stood reduction gearing and the hoist operator's platform, which were bolted to a raised concrete rim 6 by 7 feet in area. The motor, which was 2 by 3 feet in size, was bolted to a concrete pad 4½ by 4½ feet in area in the northwest corner.
