Cashier Mine and Mill Site 5ST1158

Cashier Mine History

Cashier Mine and Mill Site Description

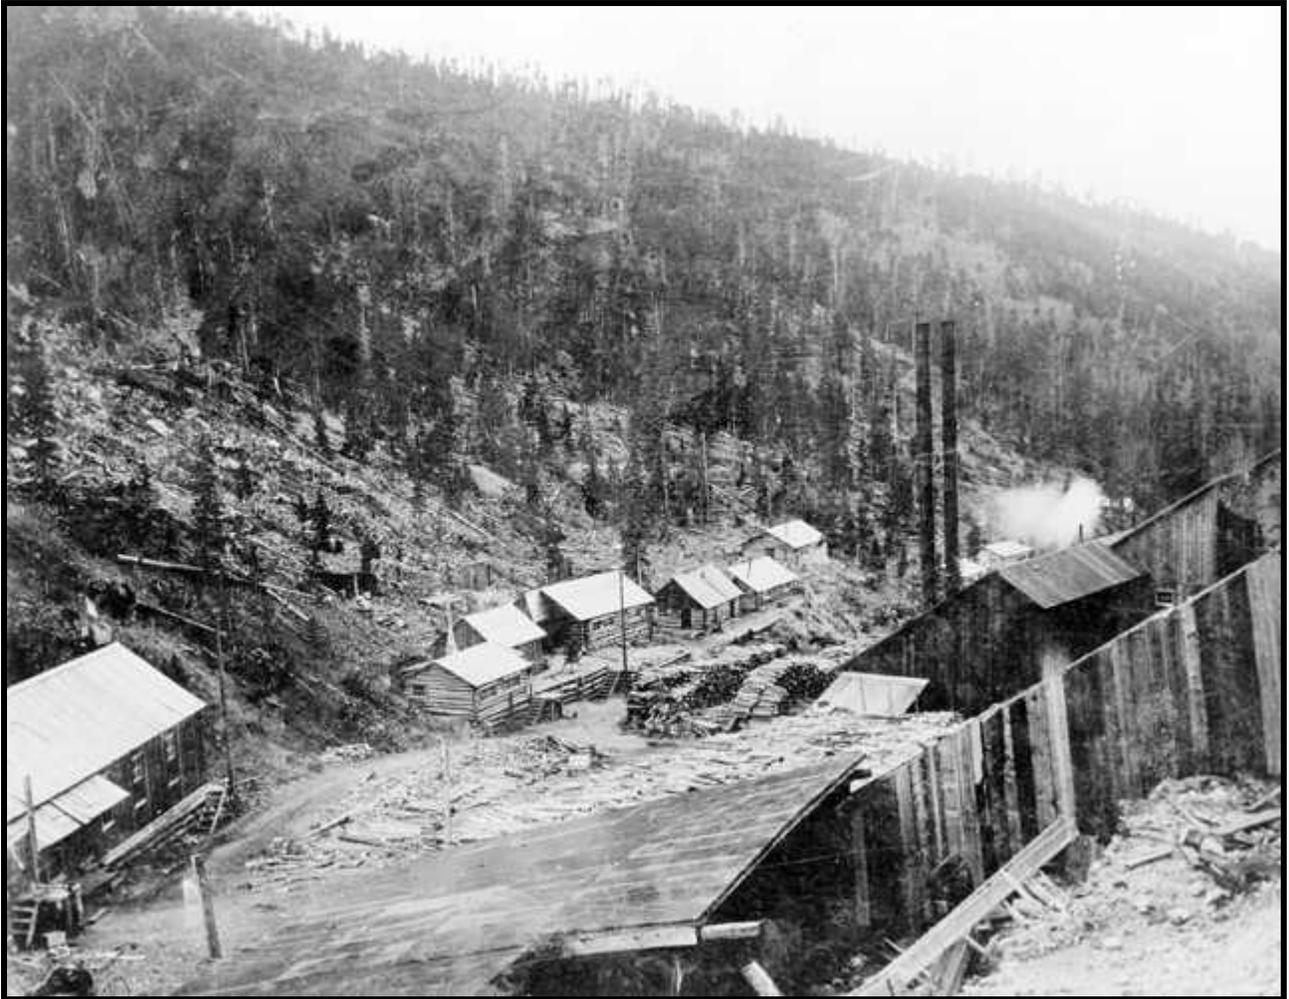
Figure 2.50: In this the northwest view taken around 1900, the Cashier Mill is at right and Brownville is at center. Today, platforms and two cabins represent Brownville, but little remains from the mill. Source: Denver Public Library, X-62421.

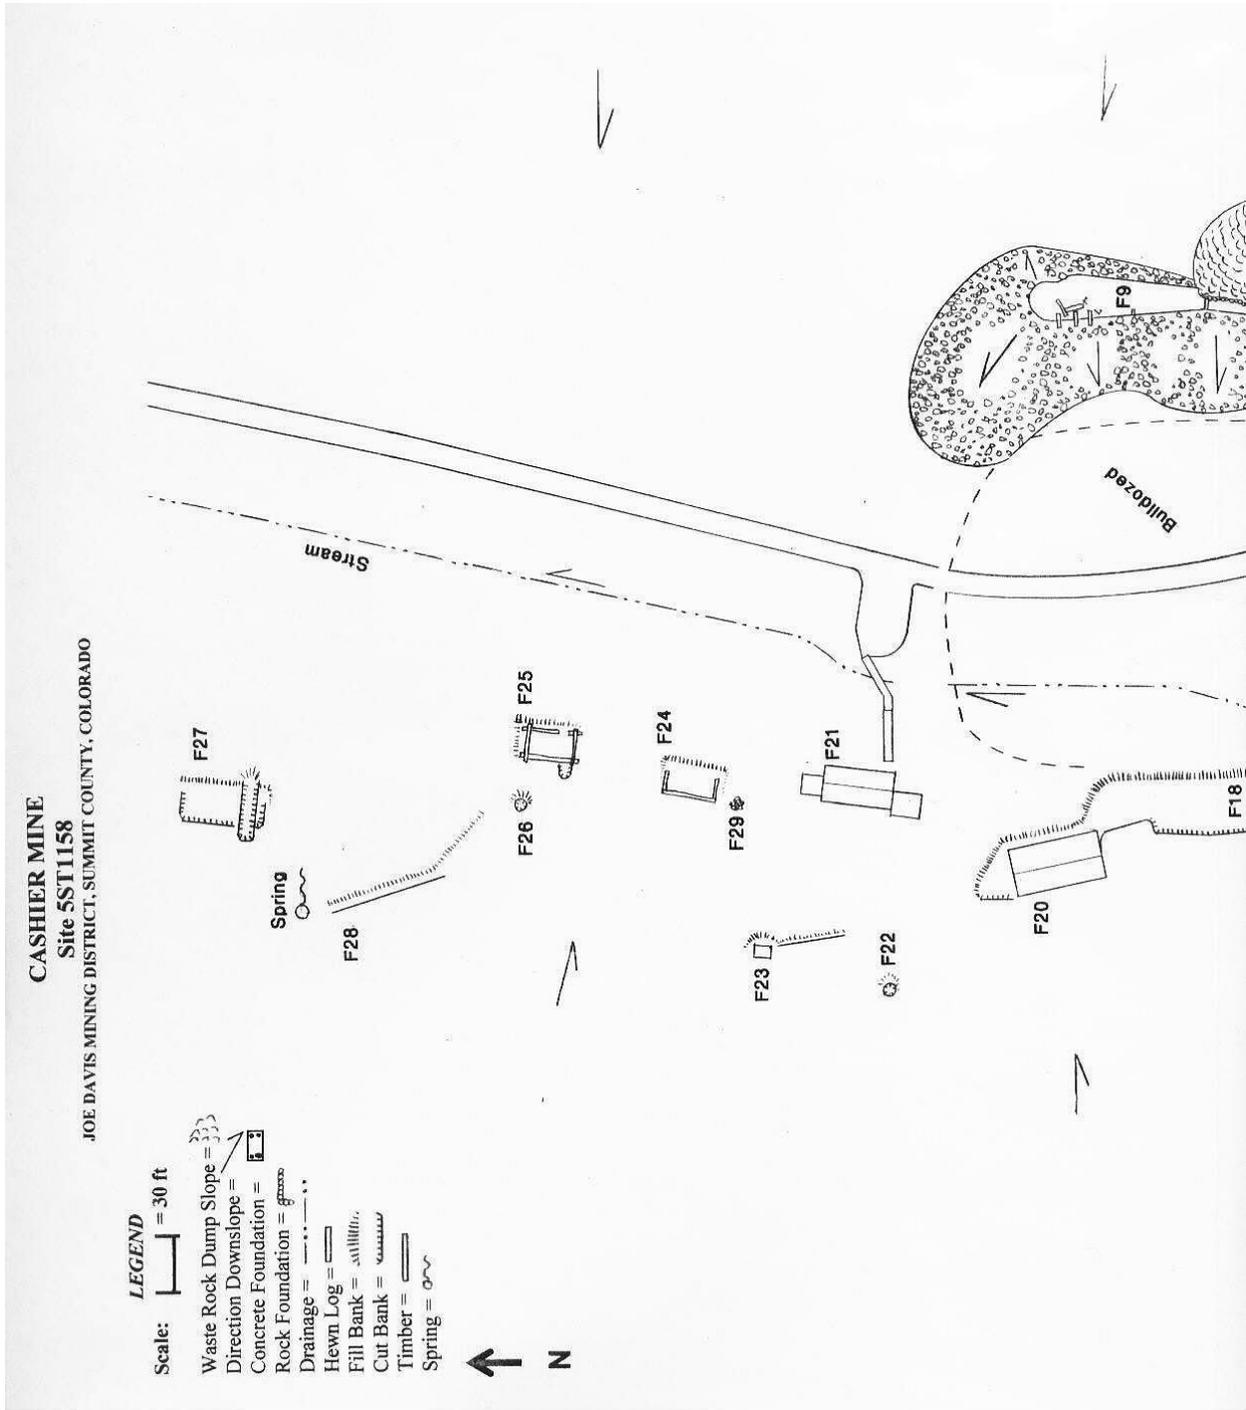
Figure 2.51: Plan view of the Cashier Mine and Mill site's north portion. The south portion is continued below. The residential features on the west side of the creek belonged to Brownville.

Miners input ore into the mill from two sources. One was through the third tunnel mentioned above, and the second was via a rail line that traversed over from the main haulageway. The track crossed a bed (F5) of waste rock fill around 5 feet wide and 200 feet long.

The mill was a complex facility that included an ore sorting house and crusher at its head, batteries of forty stamps below, concentration machinery on its bottom level, and a powerplant in a southern extension. Earth removal and bulldozing destroyed most of the mill's aspects except for the powerplant area. Foundation elements and remnants of a bin (F8) represent the sorting house, and two partial pedestals (F10) are left from the stamp mill.

The power plant included a steam engine, an air compressor, and a boiler, which foundations currently represent. The engine foundation (F11) consists of two components. The

first is a pad for the engine body, and the second is a pylon for the engine's outboard flywheel bearing. The main pad is 6½ feet wide, 24 feet long, and is constructed with mortared rock masonry. The outboard flywheel pylon is free-standing, 3 feet wide, and 10 feet long and features a concrete pillow for the bearing. In total, the foundation is 12½ feet wide and 24 feet long.

The compressor stood adjacent to the steam engine, and it provided air that powered rock drills in the mine workings. The machine was bolted to a foundation (F12) consisting of 12x12 timbers over mortared rock masonry. The foundation's footprint indicates that the compressor was a steam-driven, straight-line model 2 by 11 feet in size.

Brownville was a linear arrangement of eight boardinghouses and bunkhouses on the west side of the gulch. The southernmost building in Brownville was a cabin 12 by 17 feet in area now represented by a log foundation (F14) and debris. A few artifacts lie scattered around, and buried deposits are unlikely because soil is thin and the adjacent creek is a poor preservation environment.

The fourth building in the row of residences is an intact cabin that currently stands north of the building platforms. The cabin (F20) is a side-gabled log building 19 by 37 feet in area, 6 feet high at the roof eaves, and 10½ feet high overall. The core is a log structure 19 by 28 feet in area, and it features an addition 9 feet long on the south side. Workers assembled the core's walls with square-notch joints on a foundation of logs, and the roof consists of planks clad with tarpaper nailed to five beams that span the core's length. The main entry was in the south wall, which the addition now obstructs. The addition, built within recent decades, matches the original core's width and roof line. The walls consist of panel siding nailed to 2x4s, and the foundation is little more than wall footers laid on log bolsters. The roof is like that of the original core, except that doubled 2x4 beams were used instead of logs. The recent residents affected a number of improvements to the cabin, including new Plexiglas windows, a stovepipe, and corrugated sheet iron cladding on the roof. They chinked gaps between logs with grout, installed fresh-water plumbing, and added skylights. The residents also cached building materials, vehicle parts, and hardware around the cabin. A few historic artifacts are present, and buried deposits are unlikely due to the steep mountainside.

The site's sixth residence was a log cabin now reduced to foundation elements on a platform graded with cut-and-fill methods. The platform (F24) is 18 by 27 feet in area, and foundation logs indicate that the cabin was 15 by 22 feet in area. A few historic artifacts lie on and downslope from the platform, and buried deposits are unlikely due to the steep mountainside.

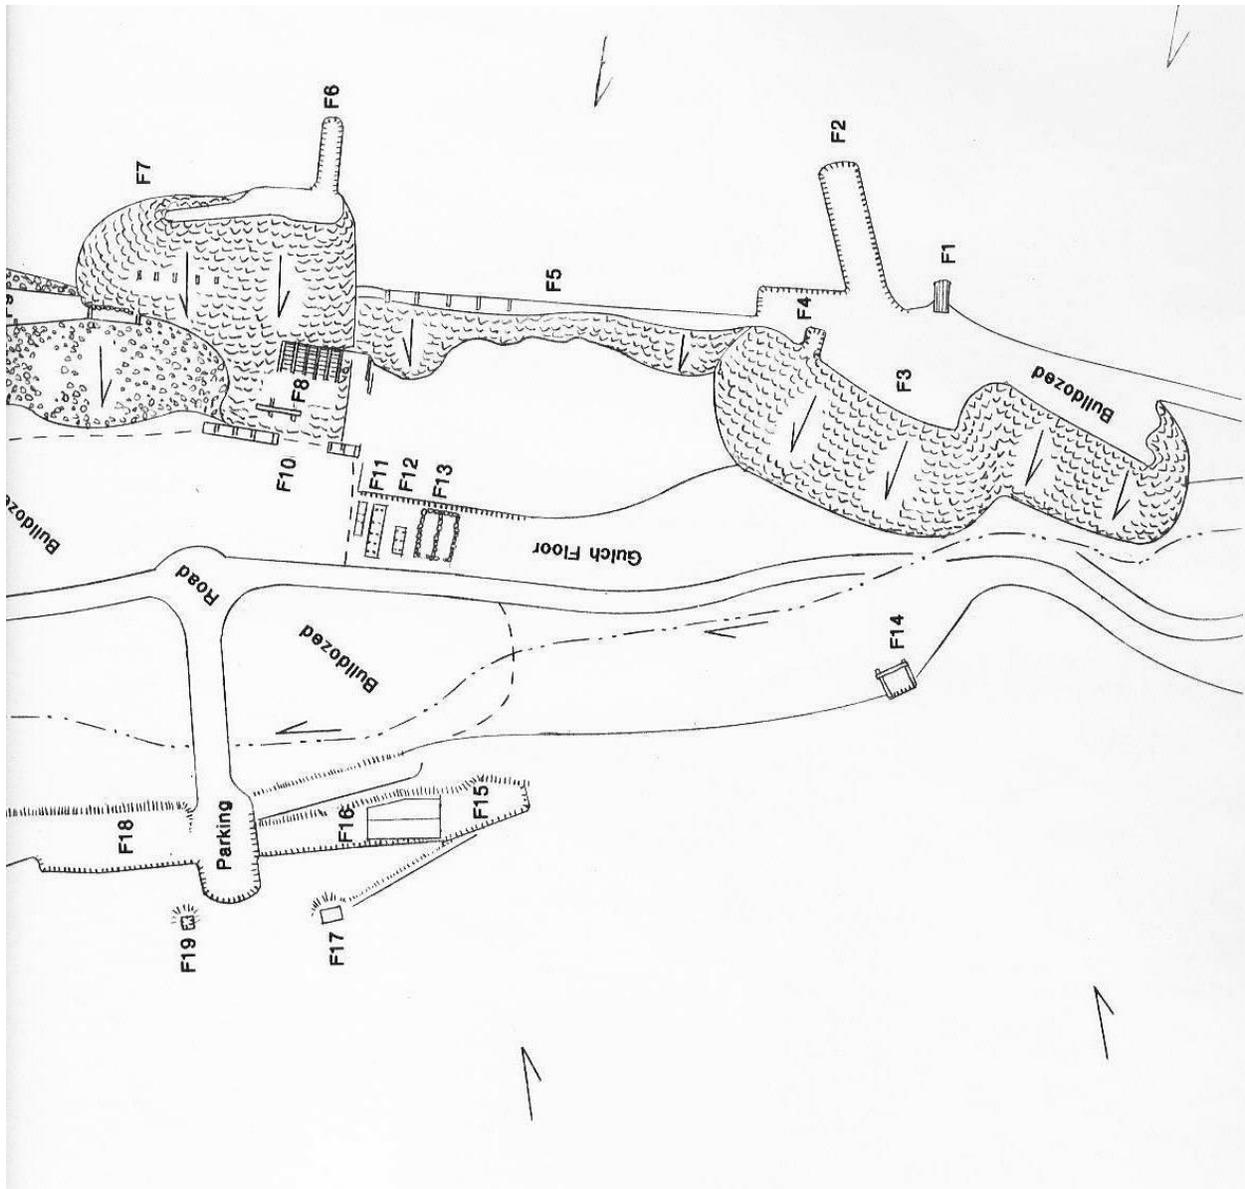
Figure 2.51: Plan view of the Cashier Mine and Mill site's south portion, continued from above.
