Architectural Inventory Form

1. Resource number: **5ST.130.137** Parcel number(s):
2. Temporary resource number: **N/A**
3. County: **Summit**
4. City: **Breckenridge**
5. Historic Building Name: **N/A**
6. Current Building Name: **French Ridge Condominiums**
7. Building Address: **409, 411, 411½ S. French Street**
8. Owner Name: **French Ridge Unit B-1 Interval Owners Association**
- Owner Organization:
- Owner Address: **P.O. Box 3580
Breckenridge, CO 80424**

47. Photograph number(s): **Breckenridge Phase IV Survey – CD-1, Images 148-152; CD-2, Images 50-53** Images filed at: **Town of Breckenridge
150 Ski Hill Road
Breckenridge, CO 80424**
48. Report title: **Town of Breckenridge Phase IV Cultural Resource Survey**
49. Date(s): **June 11, 2006**
50. Recorder(s): **Carl McWilliams** **Rebecca Waugh**
51. Organizations: **Cultural Resource Historians** **Town of Breckenridge**
52. Address: **1607 Dogwood Court** **150 Ski Hill Road**
Fort Collins, CO 80525 **Breckenridge, CO 80424**
53. Phone number(s): **(970) 493-5270** **(303) 629-6966 ext. 142**

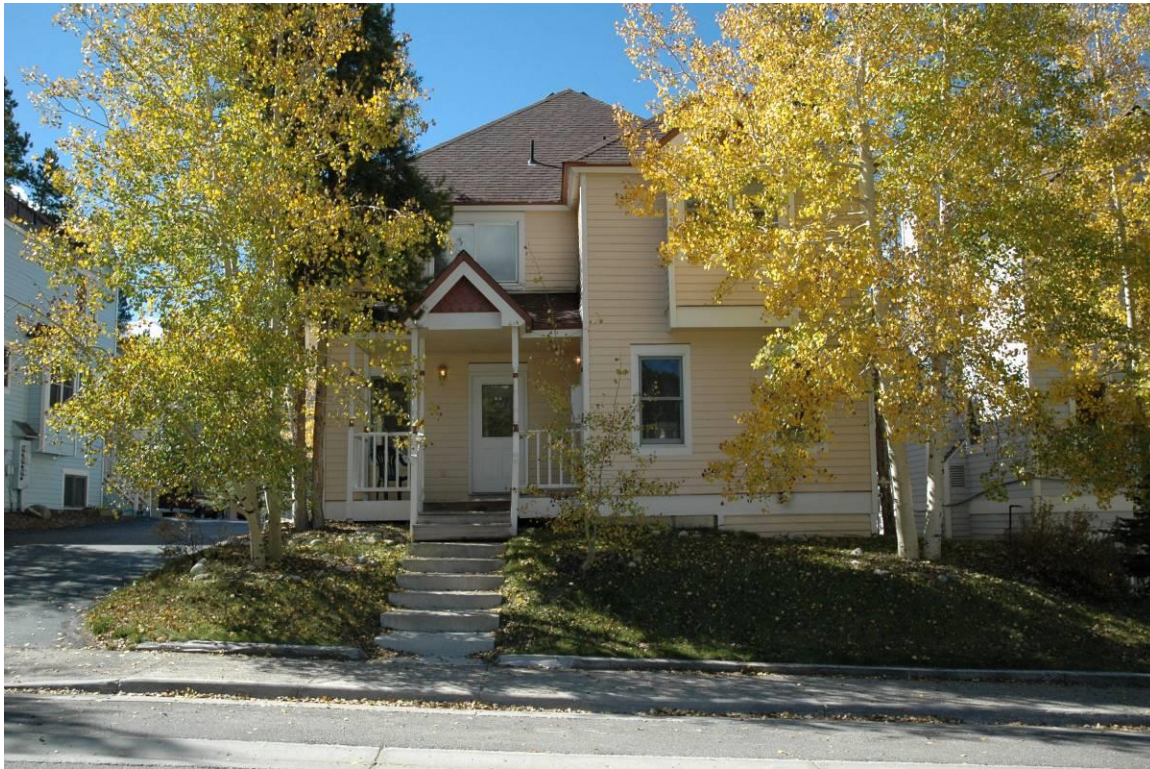
21. General architectural description:
Constructed in 1983, the building at 409 S. French Street is a tall 2½-story multiple-unit vacation dwelling which measures 29' N-S by 42' E-W. It is supported by a low concrete foundation, and its exterior walls are clad with painted light blue horizontal wood siding, with painted white 1" by 4" corner boards. Painted light blue fishscale shingles appear in the upper gable ends, however. The steeply-pitched hipped roof features a large intersecting front gable, and is covered with brown asphalt composition shingles. The eaves are boxed with painted white and blue wood trim. A tall boxed chimney is located on the west (rear) elevation. The building's windows are primarily single and paired 1/1 double-hung sash with painted white wood frames and surrounds. Three white paneled entry doors enter the building on the façade – two at the main level, and one at the recessed garden level. A white paneled door, with one upper sash light, enters the west elevation from an 8-step wood porch. A glass-in-wood-fame atrium door enters into the second story from a small balcony, also on the west elevation. A painted white glass-in-wood-frame door, with flanking sidelights, enters into the south elevation from a 9-step wood porch which wraps around the rear southwest corner.
