COLORADO CULTURAL RESOURCE SURVEY

**Architectural Inventory Form**

\_\_\_\_ Contributes to eligible National Register District

- 1. Resource number: **5ST130.80**
- 2. Temporary number: **N/A**
- 3. County: **Summit**
- 4. City: **Breckenridge**
- 5. Historic building name: **Struve / Taylor Building**
- 6. Current building name: **Wine and Cheese Shop**
- 7. Building address: **203 S. Main Street**
- 8. Owner name: **Town of Breckenridge**  
 Owner address: **P.O. Box 168**  
**Breckenridge, CO 80424**

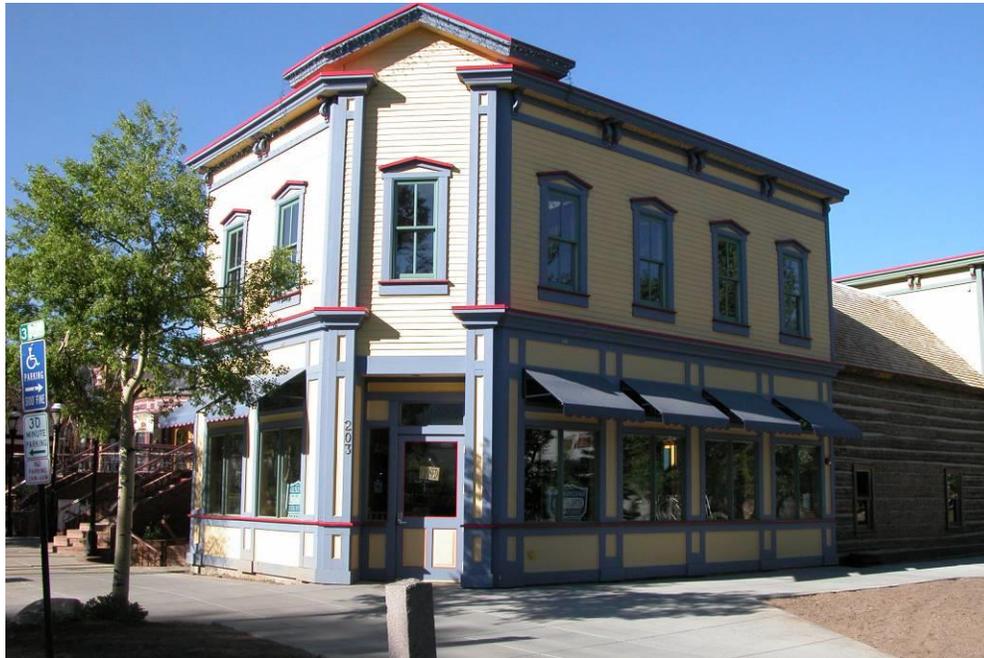
The long narrow building at 203 Main Street measures just 19' across (generally N-S), but is 108' deep (generally E-W). The eastern-most portion of the building (measuring 19' by 28') is 2.2-stories in height, and features multiple gabled roof forms; the center section of the building (measuring 19' by 30'), is two stories tall; the rear, western-most, section of the building measures 19' by 30' is three stories tall, and is covered by a saltbox roof. This building abuts 211 S. Main Street along most of its south elevation, while a large plaza lies to the north. The river walk, and the Blue River are to the west. The building is of wood frame construction, and its exterior walls are clad with vertical wood siding. The roof is covered with wood shingles, and the roof eaves are closed. A set of paired, painted green, glass-in-wood-frame entry doors lead into the facade from the wide concrete sidewalk which parallels Main Street on the east elevation. The entry doors are topped by two tall clerestory windows, while to the south of the doors the facade wall is angled where there is a band of three tall fixed-pane windows. Along the long north side elevation, there are three service entry doors, and a total of seven single-light fixed-pane or casement windows. The tall west elevation overlooks the river walk, as well as the Ten Mile Range. A 19' by 8' wood plank porch here features a painted black wood railing, and from this porch, two 1x1 horizontal glass bypass doors enter into the rear of the building. Two 6" by 6" wood posts support a second story balcony which is located directly above the rear porch. The balcony is accessed by a long wooden staircase at the west end of the north elevation. Two more 1x1 horizontal sliding glass bypass doors enter into the second story from the balcony. A smaller, third story, balcony is located at the upper north end of the west elevation.
