COLORADO CULTURAL RESOURCE SURVEY

Architectural Inventory Form

- 1. Resource number: **5ST130.90**
- 2. Temporary number: **N/A**
- 3. County: **Summit**
- 4. City: **Breckenridge**
- 5. Historic building name: **Hirsch Retail Building**
- 6. Current building name: **Hirsch Retail Building**
- 7. Building address: **216 S. Main Street**
- 8. Owner name: **Eduardo F. Bello**
Owner address: **35 Hale Kuai, No. 201**
Kihei-Maui, HI

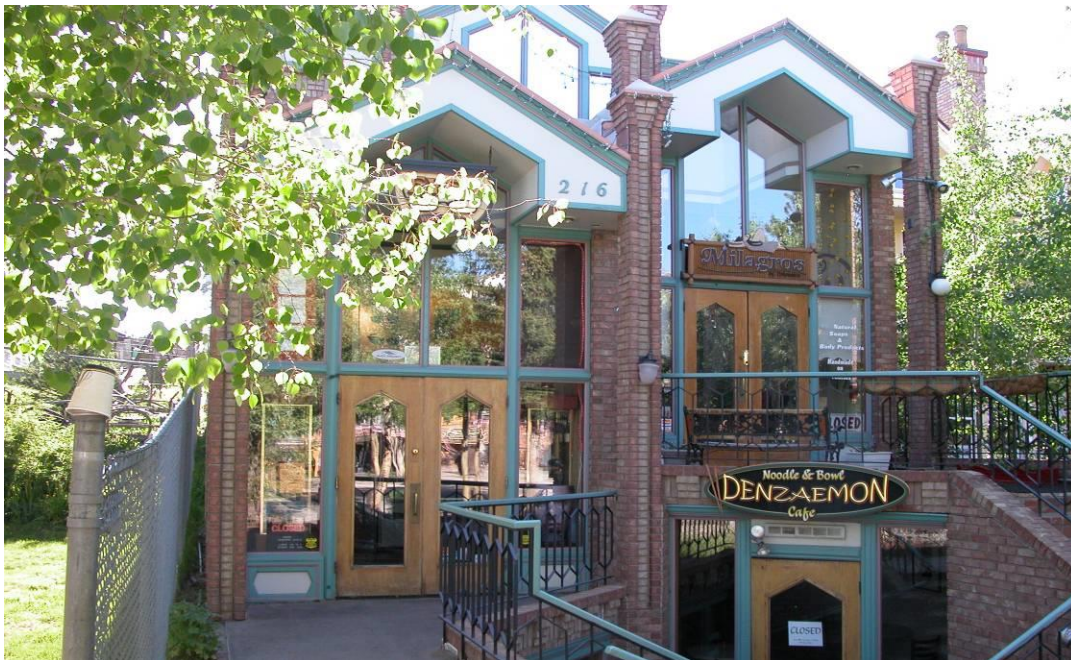
Completed in 1987, the Hirsch Retail Building is a relatively large, two-level, commercial building which presently (in 2004) houses three retail shops. Overall, it measures approximately 25' N-S (across) by 55' E-W (deep). The building's facade fronts toward South Main Street on the west elevation. The "Eyes of Breckenridge" retail shop is located at ground level, at the north end of the facade. "Milagros of Colorado" is located in the upper level, at the south end of the facade. This establishment is accessed by a set of brick and concrete stairs, flanked by distinctive wrought iron railings. Wrought iron railings also enclose a sunken centered courtyard, where another stairway descends to the "Sky Bleu Cafe." The building's eye-catching facade features multiple brick columns, with gabled roof forms over the entryways. The entrances into Milagros and the Eyes of Breckenridge both feature paired, glass-in-wood-frame entry doors, with triangular shaped lights, and with large clerestory windows and sidelights. A single glass-in-wood-frame door, also with a triangular-shaped light, leads into the Sky Bleu Cafe from the sunken courtyard. A solid wood rear service entry door is set below a gabled parapet on the east elevation. This door is flanked by two single-light fixed-pane windows. The building's long north (side) elevation wall is clad with a brick veneer at the west end, while the rear portion of the wall to the east is clad with painted grey horizontal wood siding. The east (rear) elevation wall is also clad with painted grey horizontal wood siding, while the south side elevation abuts 220 S. Main Street next door to the south. The roof is flat, covered with composition roofing material.
