COLORADO CULTURAL RESOURCE SURVEY

Architectural Inventory Form

1. Resource number: **5ST130.97**
2. Temporary number: **N/A**
3. County: **Summit**
4. City: **Breckenridge**
5. Historic building name: **Pehrson House**
6. Current building name: **Phillips House**
7. Building address: **304 S. Main Street**
8. Owner name: **Theobald Family Limited Partnership**
 Owner address: **P.O. Box 37**
Breckenridge, CO 80424

48. Report title: **Breckenridge Historic District Historical Building Survey**

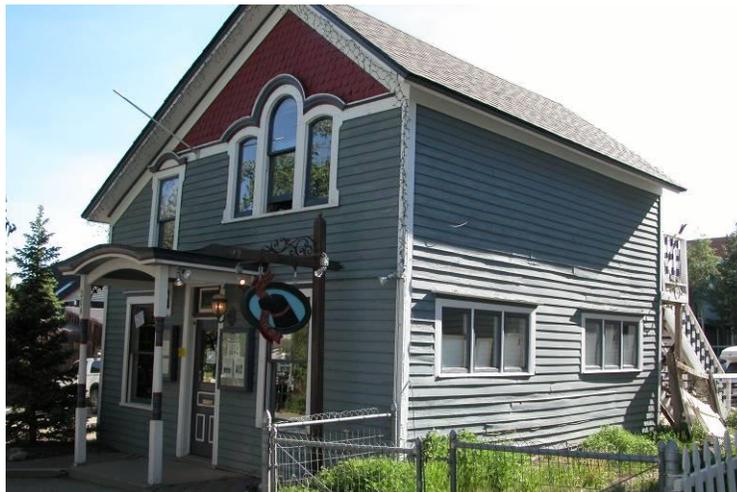
The former dwelling at 304 South Main Street in Breckenridge is a 1.5-story wood frame building which dates to 1909. The present building consists of the original 22' N-S (across) by 21' E-W (deep) front gabled house, along with a 17' by 14' 1.5-story gabled addition to the original east (rear) elevation, and an 8' by 10' shed-roofed addition built onto the rear of the gabled addition. The building's exterior walls are clad with painted blue horizontal wood siding, with painted white 1" by 4" corner boards. Painted red, octagon-shape, patterned wood shingles appear in the upper gable ends on the east and west elevations. A gabled wall dormer, located on the north elevation, features a Palladian window and patterned wood shingles. The roof forms are uniformly covered with non-historic brown metal roofing material, and the roof eaves are boxed with painted blue and white wood trim.

Two single 1/1 double-hung sash first story windows flank the entry door on the facade (west elevation). The upper facade wall is penetrated by a Palladian-style window, and by a 1/1 double-hung sash window, with a molded hood. Windows on the south elevation include two bands of three single-light fixed-pane windows. On the north elevation, there are two 1/1 double-hung sash windows, and one 4-light window. A single 4-light window penetrates the upper gable end of the gabled addition on its east elevation; a 1/1 double-hung sash window penetrates the upper gable end of the original dwelling on its east elevation.

A painted red, white, and blue wood-paneled door, with one upper sash light, and with a transom light, is located near the center of the facade. This door leads into the building from a 6' by 4' concrete porch, covered by a molded hood supported by two turned columns. Another painted red, white, and blue wood-paneled door, with one upper sash light, is located near the east end of the north elevation. This door enters into the gabled addition from a 4' by 14' shed-roofed porch with three chamfered columns. Another painted red, white, and blue wood-paneled door enters into the gabled addition on the east elevation. Also on the east elevation, a set of fifteen metal steps lead to another painted red, white, and blue wood-paneled door which enters the building's upper half story.
