COLORADO CULTURAL RESOURCE SURVEY

Architectural Inventory Form

- 1. Resource number: **5ST130.104**
- 2. Temporary number: **N/A**
- 3. County: **Summit**
- 4. City: **Breckenridge**
- 5. Historic building name: **Bradley Cabin**
- 6. Current building name: **Assay Office**
- 7. Building address: **330 S. Main Street**
- 8. Owner name: **Frank K. Scott**
Owner address: **440 Springline Dr.**
Naples, FL

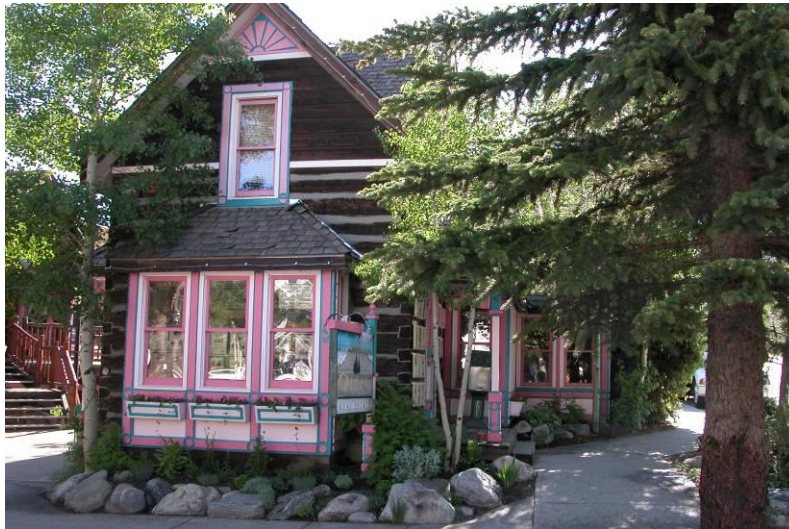
Composed of a historic log cabin (moved from its original location, and renovated with modern additions and alterations), this building is located at the northeast corner of South Main Street and Jefferson Avenue, near the south end of downtown Breckenridge. The building's original walls are built of hewn squared logs, with flush square-notched corners. Stained natural brown horizontal wood siding appears in the upper gable ends on the north and south elevations, and there are non-historic sunburst motif gable ornaments in the upper gable ends on the north, south, and east elevations. The building is covered by steeply-pitched intersecting gable roof forms, covered with wood shingles. The roof eaves are boxed, with stained natural brown wood trim. The building features hipped-roof bay windows on its west and south elevations, with 1/1 double-hung sash windows, decorative wood panels, and flower boxes. A large single-light fixed-pane window, with flanking 1/1 double-hung sash windows, and with large expanses of clerestory windows in an intersecting gable end, is located on the north elevation. (All of the windows also feature painted teal and pink wood surrounds.) A wood-paneled door, with one upper sash light, enters into the building from a 32' by 10' wood plank porch, at the west end of the south elevation. This porch is covered by a hipped roof, supported by a single squared corner post. A glass-in-wood-frame door leads into the building's north elevation, from a 5-step wood plank and brick porch. A set of paired, 12-light, glass-in-wood-frame doors, with flanking sidelights, enters the building on the west elevation. The building presently houses the Omni Real Estate offices.
